## SITE NAME

### PV System Inspection Report

Power: 0.85 MW<sub>DC</sub>  
Module Technology: Monocrystalline  
Racking: Fixed-tilt 15°  
Azimuth: 15° SW  
Location: LATITUDE, LONGITUDE

Report Generated: May 11, 2018

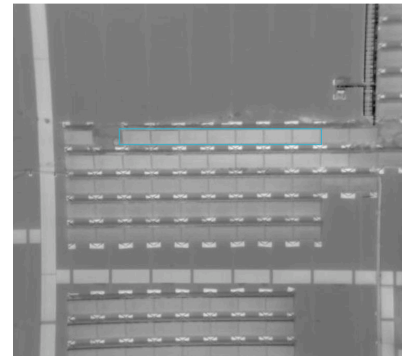
Module

Modules presents as hotter than the surrounding modules. Possibly string issue(s).

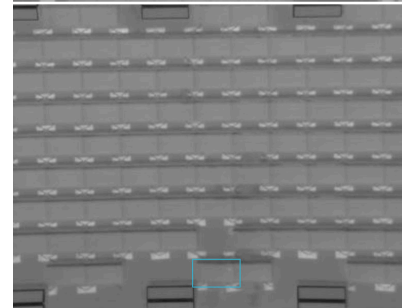
Cell

Single hot spot with distinct geometry.

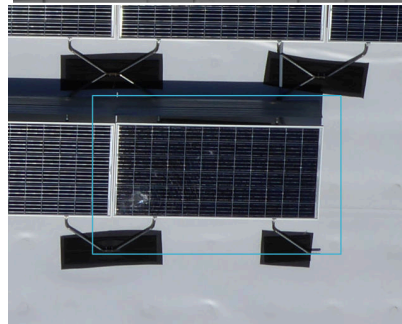
Cracking

Cracked or shattered glass on module.

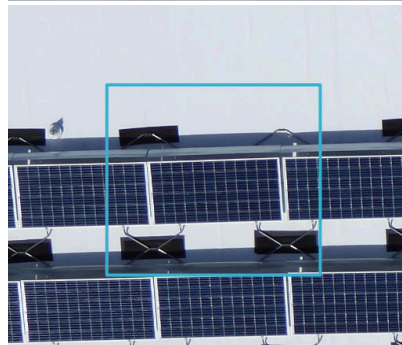
Other

Missing slip sheets on roof mount.

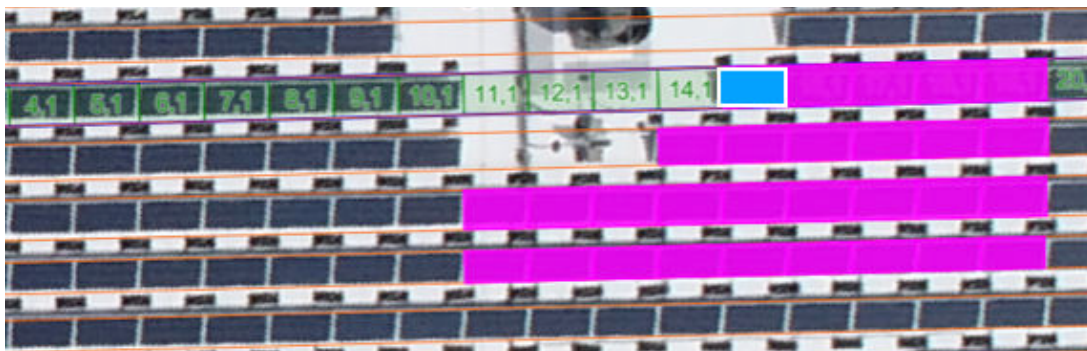
Highlighted defect in Section 2, Row 25, Position 15.

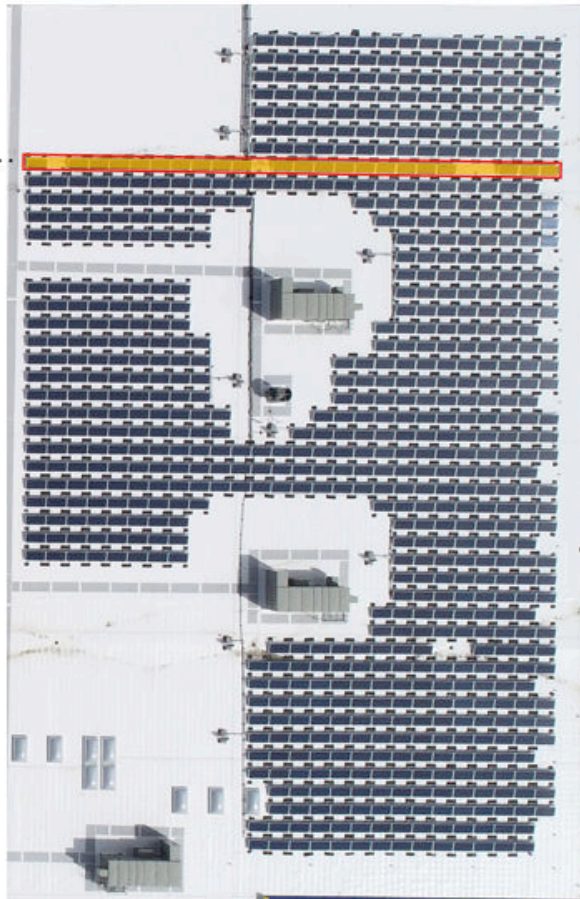
**Section 2  
Row 39**

**Defects detected in Section 2, Row 39, Modules 3-9**
