## SITE NAME

### PV System Inspection Report

Power: 0.85 MW<sub>DC</sub>  
Module Technology: Monocrystalline  
Racking: Fixed-tilt 15°  
Azimuth: 15° SW  
Location: LATITUDE, LONGITUDE

Report Generated: May 11, 2018

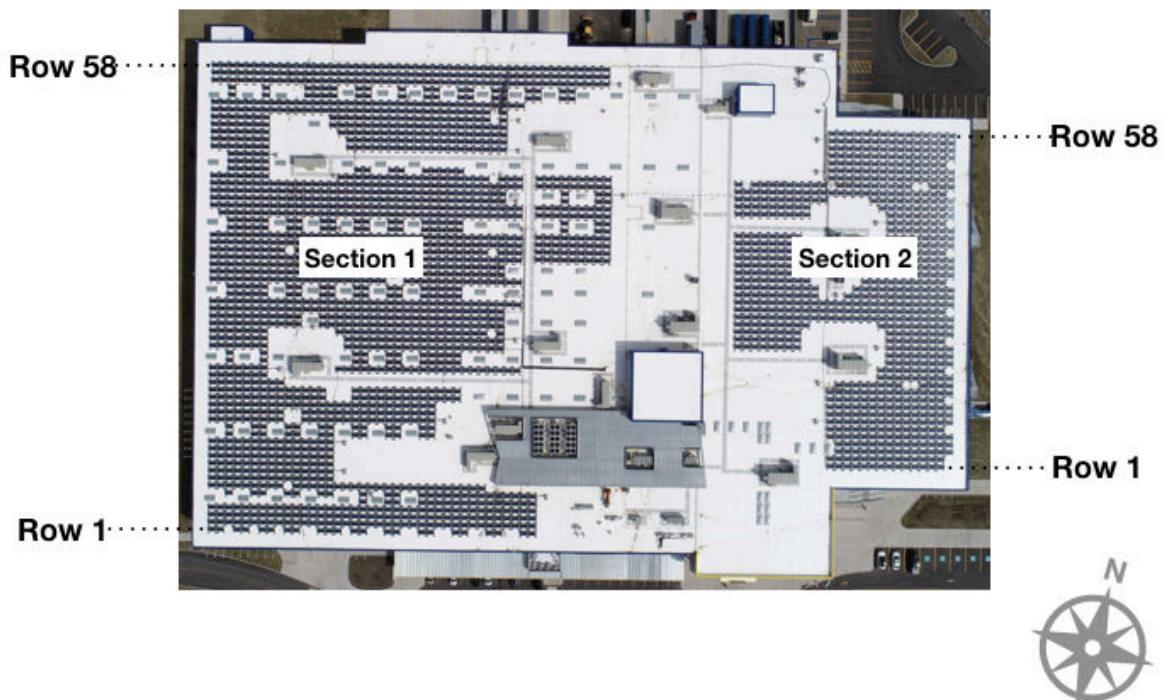
### OVERVIEW OF SITE AND ARRAYS ANALYZED (ROW NUMBERING):

Defects at the SITE NAME Solar Project are localized using local coordinate systems defined for each section. The Section number (1- for west, 2- for east) is given, followed by the row number (south-north) for the row. All GPS locations in the .KML files are accurate to the nearest module.

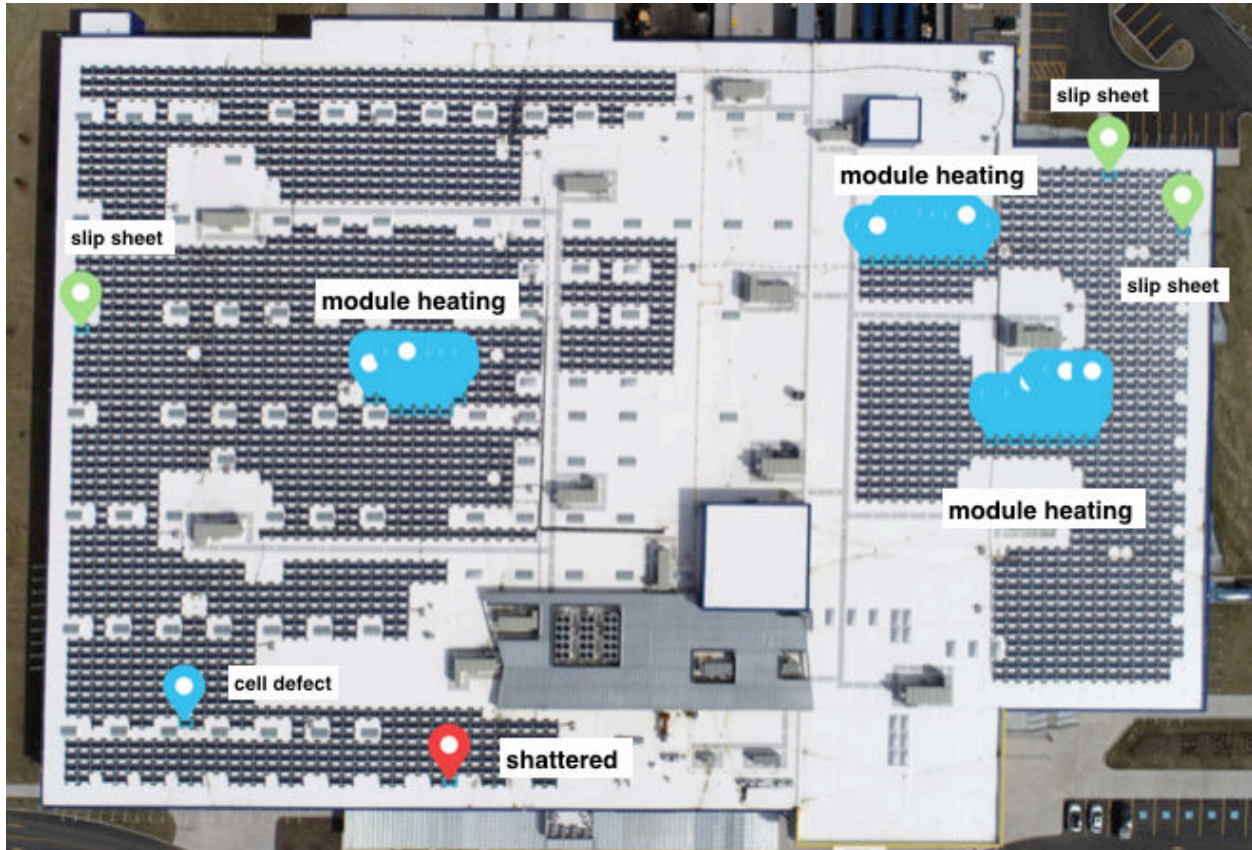
# SITE NAME Solar Project

Defects are indicated with colored pins.
